**Flood Control Project Maintenance  
Levee Inspections**  
**LMA District Cover Sheet**  
**Spring 2011 Levee Inspection Results**

**Reclamation District No. 0784 Plumas Lake**

**Levee Inspection Report By Mile - Spring 2011**

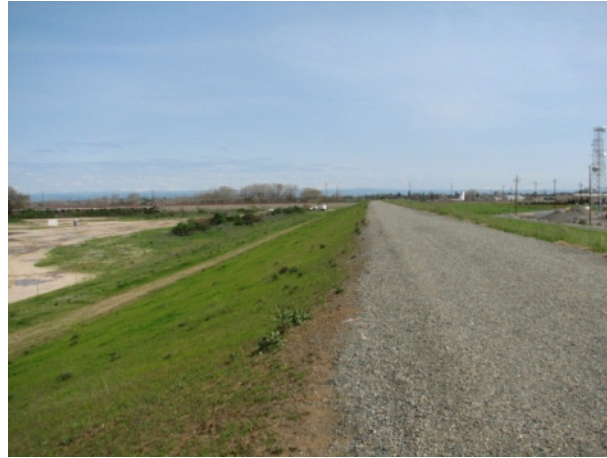
Levee Mile Report Line	3
Start Levee Mile	1.68
End Levee Mile	1.68
Location	Water Side
Category	Earthen Levee
Item	Vegetation

Levee mile 1.68, looking at the vegetation on the waterside slope.

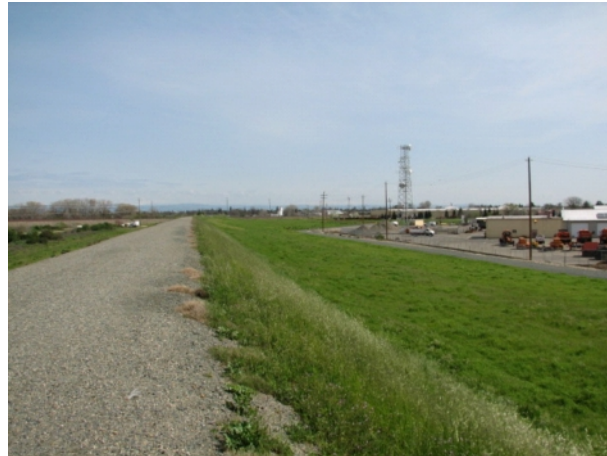
Levee Mile Report Line	4
Start Levee Mile	1.68
End Levee Mile	1.68
Location	Land Side
Category	Earthen Levee
Item	Vegetation

Levee mile 1.68, looking at the vegetation on the landside slope.

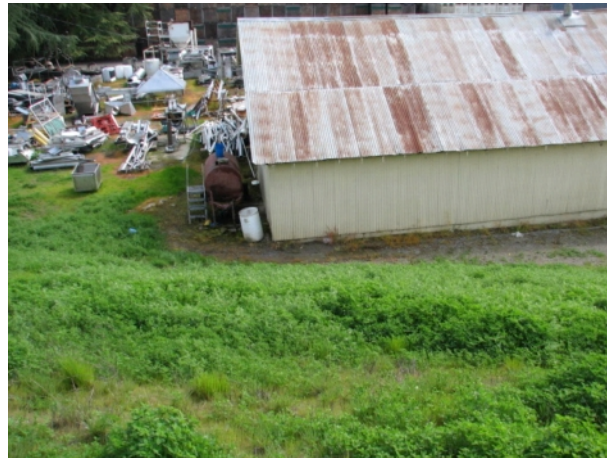
Levee Mile Report Line	1
Start Levee Mile	9.40
End Levee Mile	9.40
Location	Land Side
Category	Earthen Levee
Item	Encroachments

Levee mile 9.40, looking at a building that is encroaching on the levee toe.

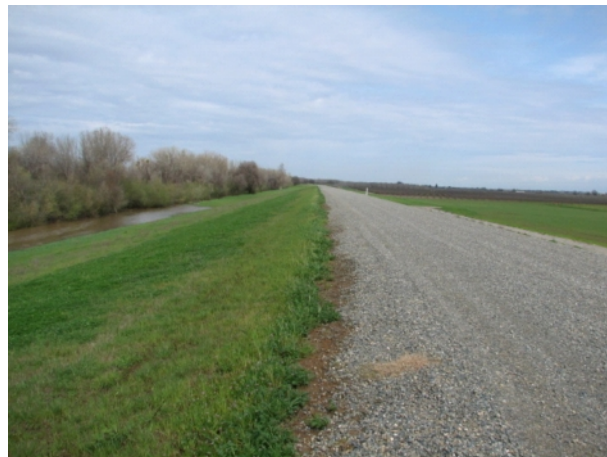
Levee Mile Report Line	2
Start Levee Mile	12.12
End Levee Mile	12.12
Location	Water Side
Category	Earthen Levee
Item	Vegetation

Levee mile 12.12, looking at the vegetation on the waterside slopel.

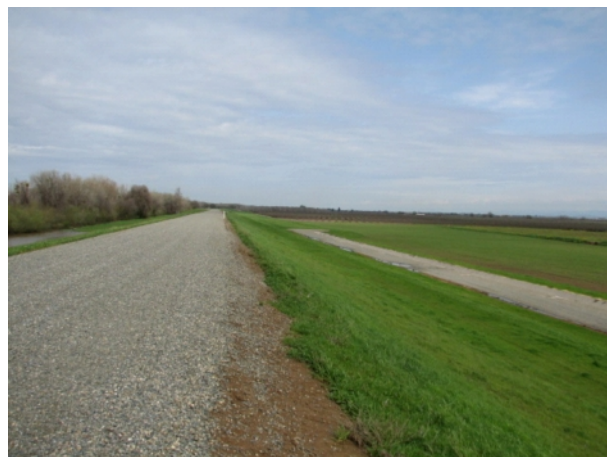
Levee Mile Report Line	3
Start Levee Mile	12.12
End Levee Mile	12.12
Location	Land Side
Category	Earthen Levee
Item	Vegetation

Levee mile 12.12, looking at the vegetation on the landside slope.

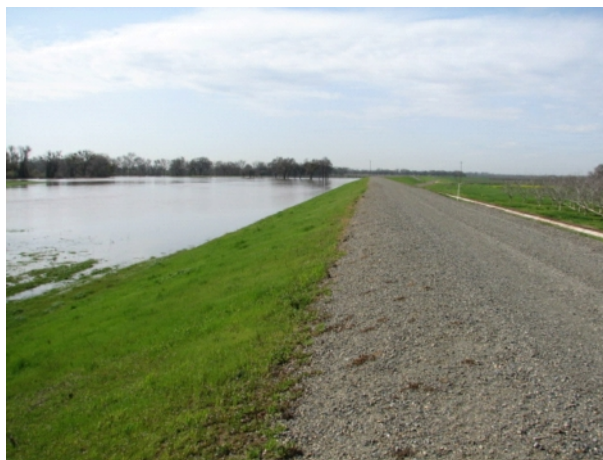
Levee Mile Report Line	1
Start Levee Mile	0.00
End Levee Mile	4.71
Location	Water Side
Category	Earthen Levee
Item	Vegetation

Levee mile 2.44, looking downstream at the vegetation on the waterside slope.

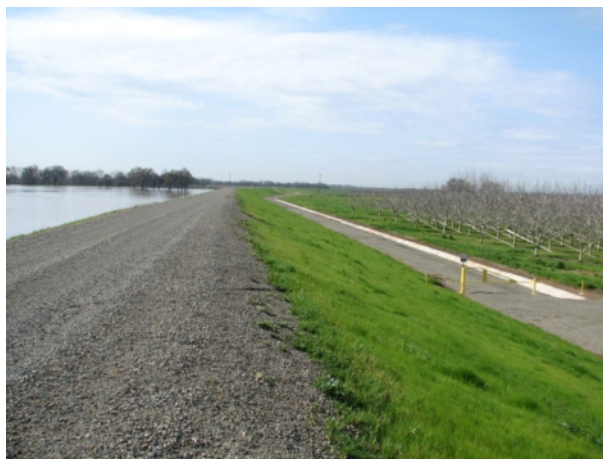
Levee Mile Report Line	2
Start Levee Mile	0.00
End Levee Mile	4.71
Location	Land Side
Category	Earthen Levee
Item	Vegetation

Levee mile 2.44, this photo is looking downstream at the vegetation on the landside slope.

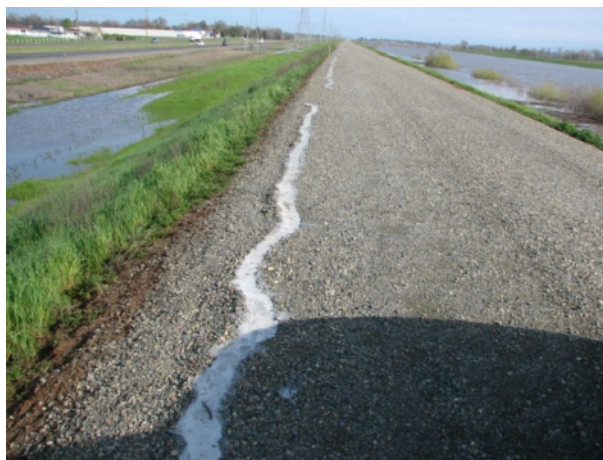
Levee Mile Report Line	3
Start Levee Mile	4.31
End Levee Mile	4.43
Location	Crown
Category	Earthen Levee
Item	Erosion / Bank Caving

Levee mile 4.31, looking at a crack near the landside shoulder with a temporary repair.

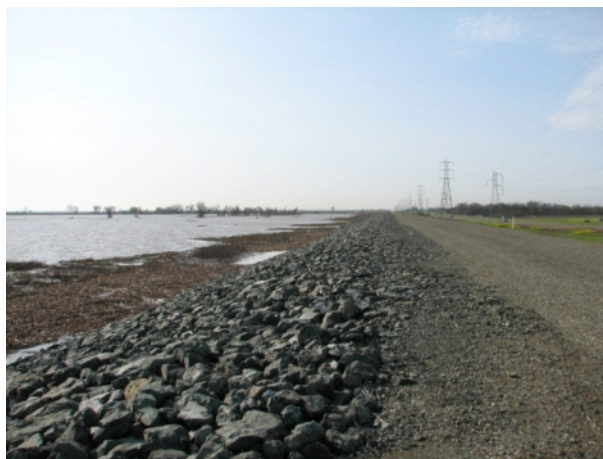
Levee Mile Report Line	4
Start Levee Mile	5.56
End Levee Mile	5.56
Location	Water Side
Category	Earthen Levee
Item	Vegetation

Levee mile 5.56, looking at the rock revetment on the waterside slope.

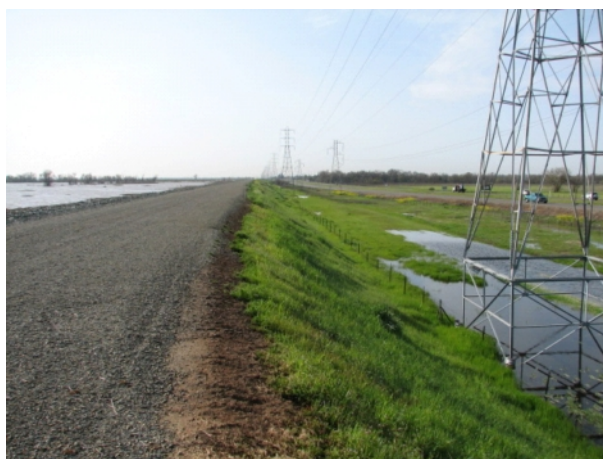
Levee Mile Report Line	5
Start Levee Mile	5.56
End Levee Mile	5.56
Location	Land Side
Category	Earthen Levee
Item	Vegetation

Levee mile 5.56, looking at the vegetation on the landside slope.

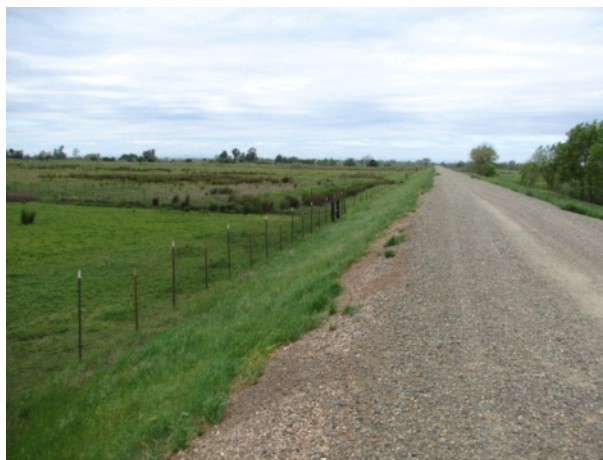
Levee Mile Report Line	1
Start Levee Mile	0.00
End Levee Mile	3.87
Location	Land Side
Category	Earthen Levee
Item	Vegetation
Levee mile 3.87, looking downstream at the vegetation on the landside slope.	
cathom_s_20110505_156.jpg

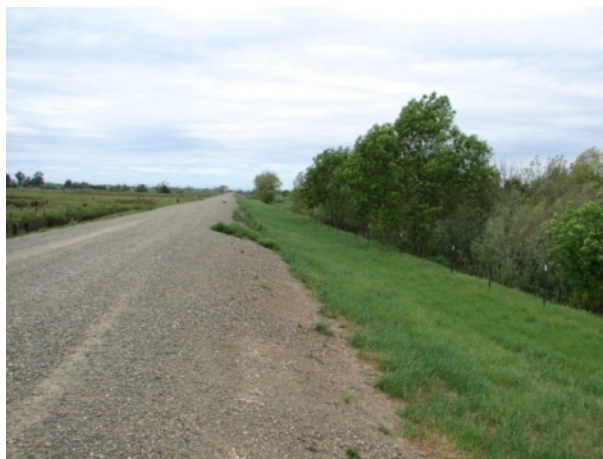
Levee Mile Report Line	2
Start Levee Mile	0.00
End Levee Mile	3.87
Location	Water Side
Category	Earthen Levee
Item	Vegetation
Levee mile 3.87, looking downstream at the vegetation on the waterside slope.	
cathom_s_20110505_157.jpg

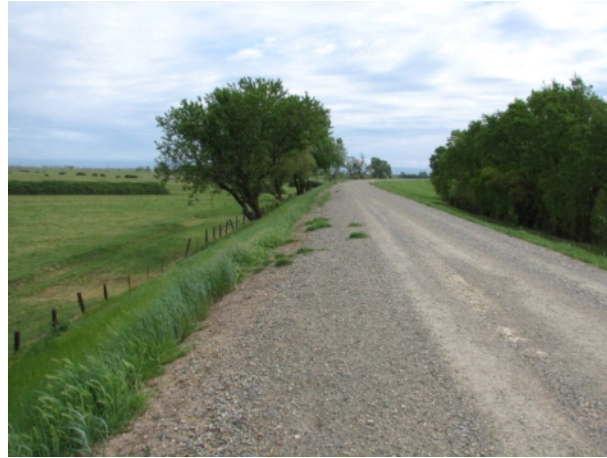
Levee Mile Report Line	1
Start Levee Mile	0.00
End Levee Mile	0.25
Location	Land Side
Category	Earthen Levee
Item	Vegetation
Levee mile 0.00, looking upstream at the vegetation on the landside slope.	
cathom_s_20110505_159.jpg

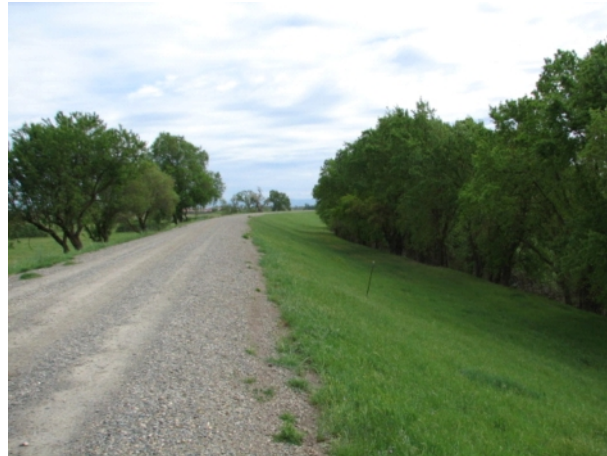
Levee Mile Report Line	2
Start Levee Mile	0.00
End Levee Mile	0.25
Location	Water Side
Category	Earthen Levee
Item	Vegetation
Levee mile 0.00, looking upstream at the vegetation on the waterside slope.	
cathom_s_20110505_158.jpg

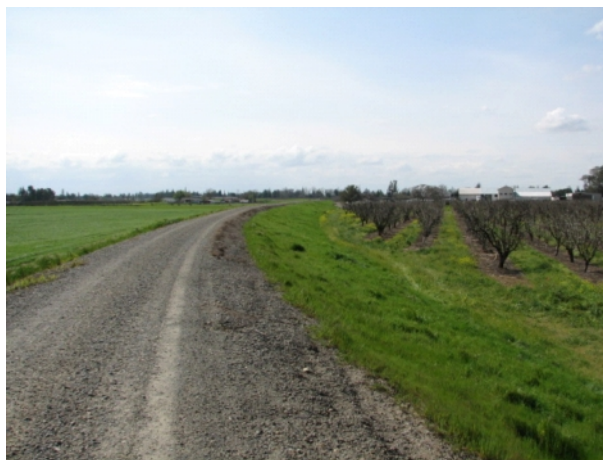
Levee mile 1.68, looking at the vegetation on the waterside slope.

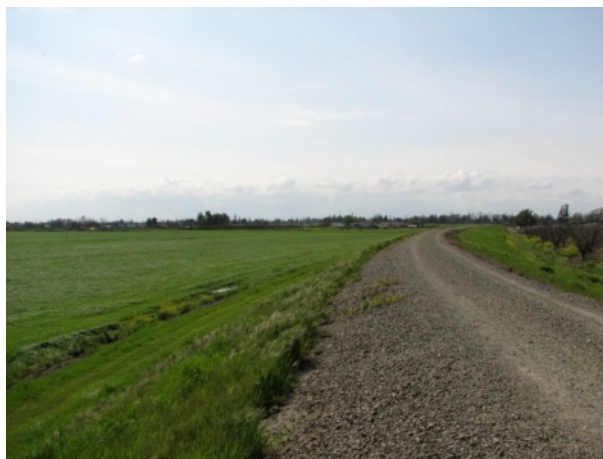
Levee Mile Report Line	4
Start Levee Mile	1.68
End Levee Mile	1.68
Location	Land Side
Category	Earthen Levee
Item	Vegetation

Levee mile 1.68, looking at the vegetation on the landside slope.

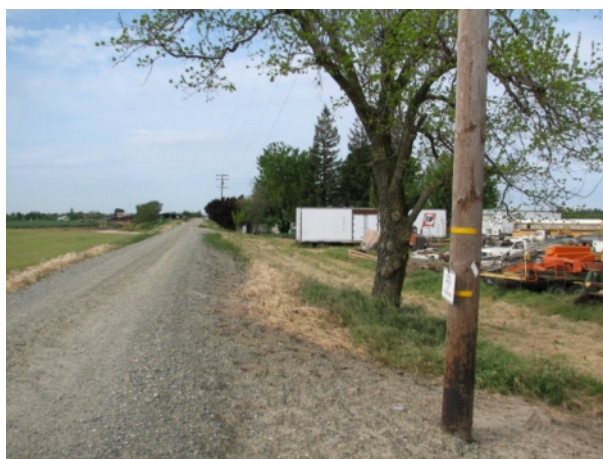
Levee Mile Report Line	5
Start Levee Mile	2.18
End Levee Mile	2.18
Location	Water Side
Category	Earthen Levee
Item	Encroachments

Water side buildings and equipment levee mile 2.18.

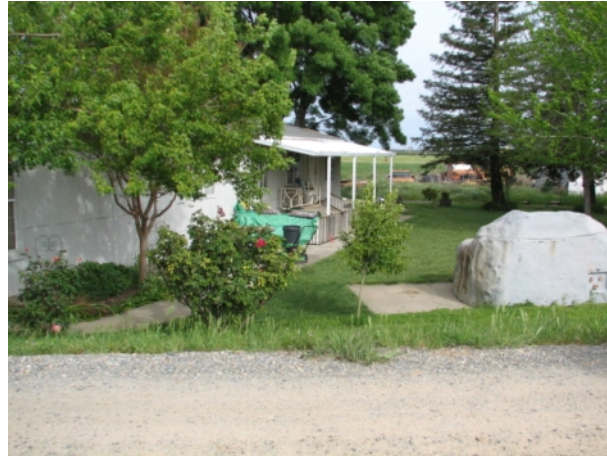
Levee Mile Report Line	5
Start Levee Mile	2.18
End Levee Mile	2.18
Location	Water Side
Category	Earthen Levee
Item	Encroachments
Water side buildings and equipment levee mile 2.18.	
cathom_s_20110228_077.jpg

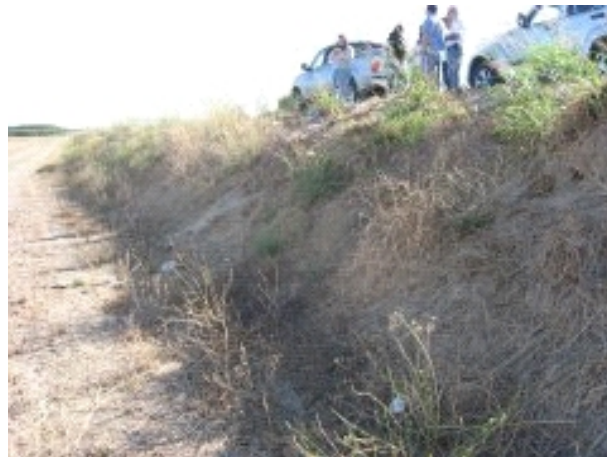
Levee Mile Report Line	6
Start Levee Mile	2.28
End Levee Mile	2.58
Location	Water Side
Category	Supplemental
Item	USACE Erosion Survey
2009: no berm, 1:1 slope, seepage, sands and silts, 0 ft/s [2009 SiteID:YUB_2-3_L]	
cathom_s_20110228_078.JPG

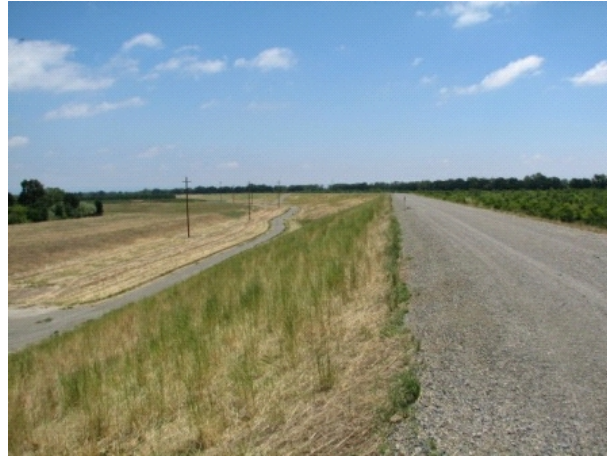
Levee mile 0.04, this photo is showing the vegetation on the landside slope.

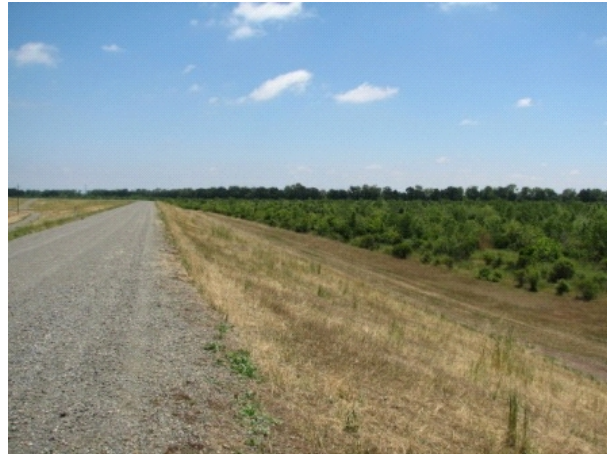
Levee Mile Report Line	2
Start Levee Mile	0.04
End Levee Mile	1.88
Location	Water Side
Category	Earthen Levee
Item	Vegetation

Levee mile 0.04, this photo shows the vegetation on the waterside slope.

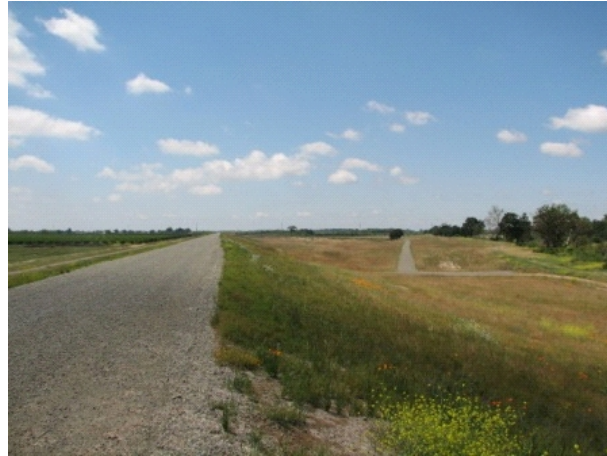
Levee mile 0.04, this photo is showing the vegetation on the waterside slope.

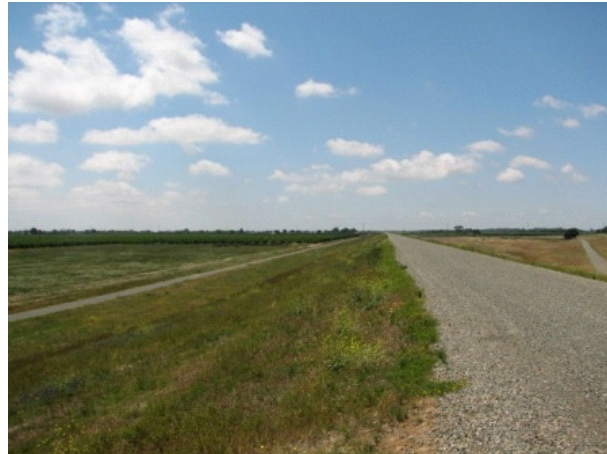
Levee Mile Report Line	2
Start Levee Mile	0.04
End Levee Mile	5.63
Location	Land Side
Category	Earthen Levee
Item	Vegetation

Levee mile 0.04, this photo is showing the vegetation on the landside slope.
